Organising to prevent failures of a high reliability system – lessons from the Santiago de Compostela railway disaster

The Santiago de Compostela disaster occurred on the Ourense-A Coruña high-speed line in the evening of July 24th, 2013. Train no. 4155 operated by the Spanish National Railways RENFE running from Madrid to Ferrol in the northwest of Spain crashed at a curve before entering the station of Santiago de Compostela. 79 passengers died, many were badly injured. Hence, the Santiago disaster was the most severe railway catastrophe in Europe since the Eschede disaster killing 101 persons on June 3rd, 1998 (cf. Kühlwetter et al. 2009). According to subsequent investigations made by the Spanish authorities, the train entered the curve “A Grandeira” at a speed of 179 km/h instead of the 80 km/h permitted for this section (cf. CIAF 2014: 97 f.; ERI 2013: 534 f.). A precise description of the events directly preceding the accident is available in the final accident report published by the Spanish commission on railway accidents (CIAF 2014: 95 ff.). The crashed train was a Talgo combined electric and diesel traction composition including two power heads with generator cars align

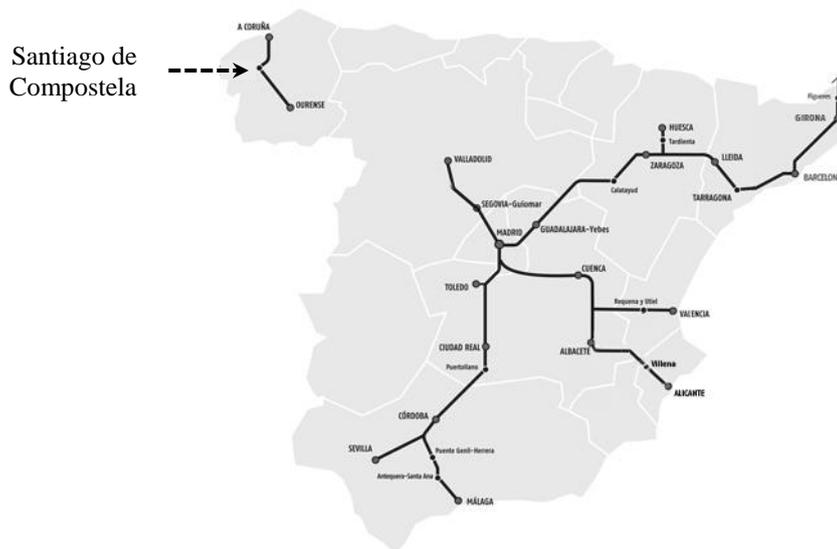
Secondly, the unfortunate alignment of the track made the “A Grandeira” curve very vulnerable to severe accidents. High-speed trains arrive to it from an almost perfectly straight track, but the high-speed line suddenly ends in front of the Santiago station to re-begin later in direction of A Coruña. Trains enter the problematic curve right after exiting a small tunnel. If the speed excess had occurred on a more straight part of the track, chances to break the train sufficiently to pass the dangerous curve section would have been higher. In fact, running at 195km/h, the locomotive driver succeeded to activate the emergency brake shortly before entering the curve and thus reduced the speed in the curve to the 179km/h reported above. No reflections on the general infrastructure planning or the alignment of the track can be found in the accident report published by the Spanish authorities (cf. CIAF 2014).

Figure 1: The isolated position of the Ourense-A Coruña high-speed line. Source: ADIF (http://www.adifaltavelocidad.es/es_ES/infraestructuras/lineas_de_alta_velocidad/lineas_de_alta_velocidad.shtml)
